# The design and construction of masonry water supply tanks

Bulletin No. 302

AGRICULTURAL ENGINEERING SECTION

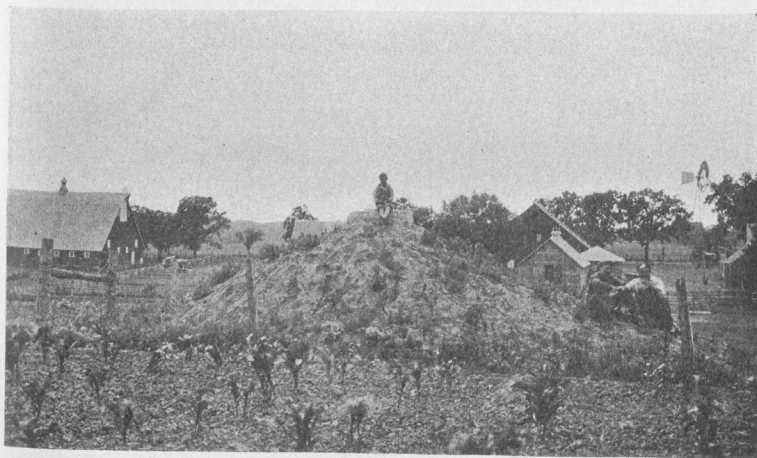
Fig. 1. An underground cistern.

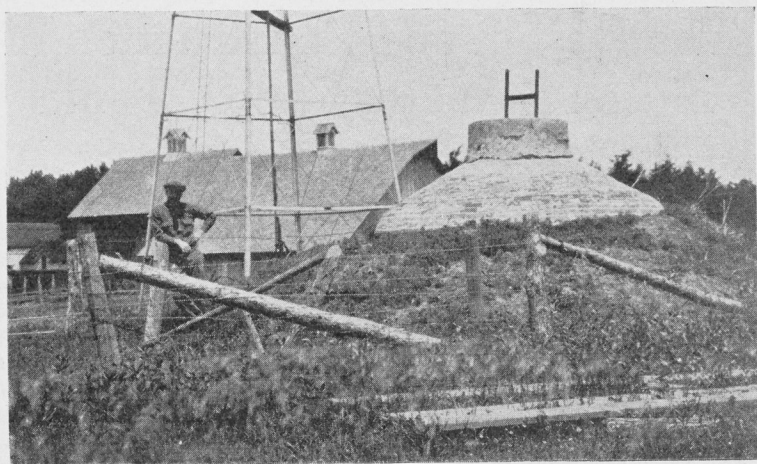
Fig. 2. Cistern with top exposed.

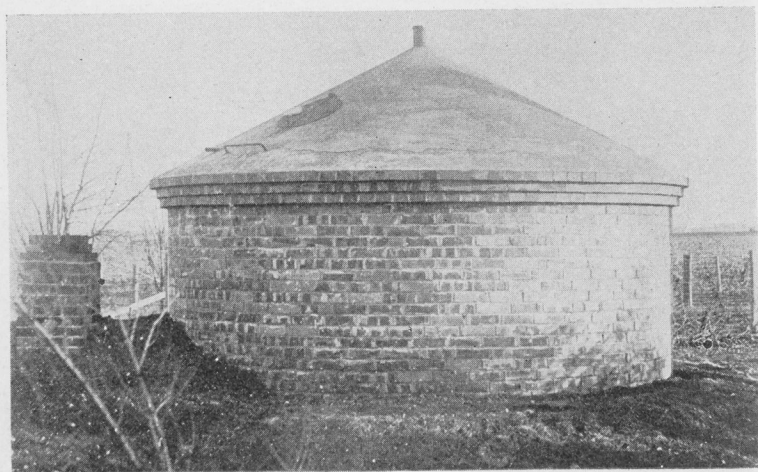
Fig. 3. Storage tank partly above ground.

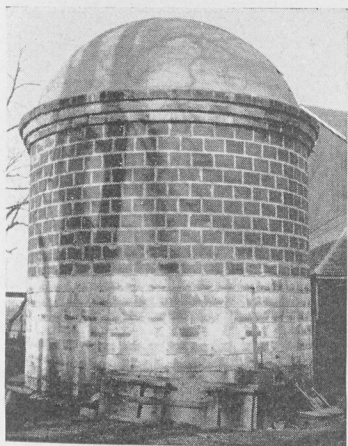
Fig. 4. Supply tank at ground level.

farmstead is located on a hillside, it may be possible to find a place near the house high enough so that the tank may be placed on the ground. It may even be placed in the ground in which case, difficulties resulting from freezing temperatures are greatly reduced. Examples of tanks thus located are shown in figs. 1, 2, 3 and 4. When elevation above the ground is necessary to secure the desired fall and pressure, various methods may be employed. Little elevation is necessary to force water to stock tanks. For fire protection, however, the tank should be well above the tallest structure.

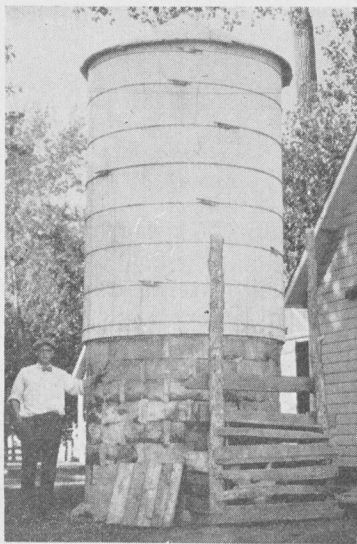
Fig. 5. Wood tank on low concrete block base.

In fig. 5 a wooden tank is placed on a slight elevation and

supported by a concrete block wall. When this type of construction is employed, the space under the tank may be used as a milk house or a stock tank (fig. 6). The tank in fig. 7 is elevated somewhat and supported upon a low wooden tower.

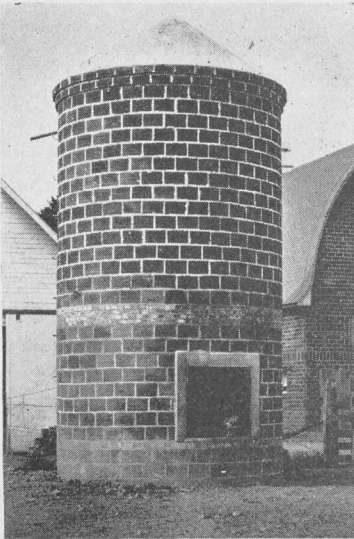
Fig. 6. Supply tank support used for stock water tank.

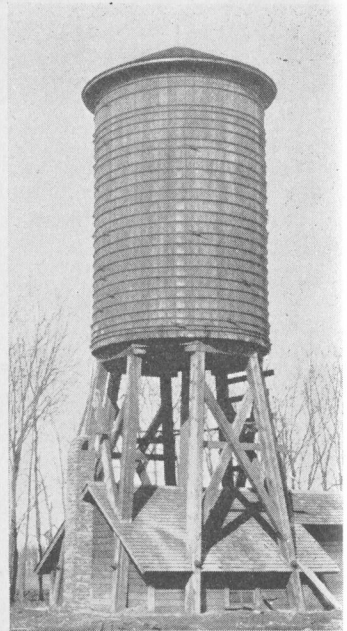
Fig. 7. Wood tank on wood tower.

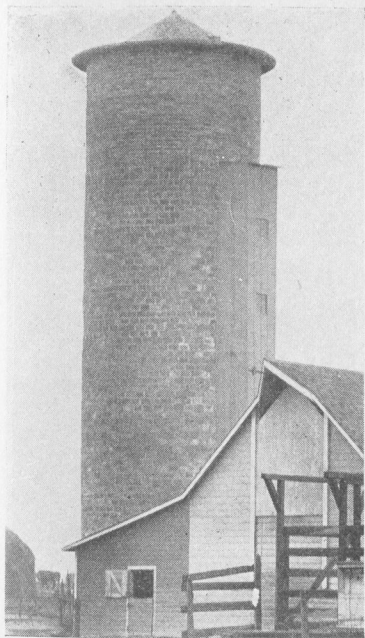
Fig. 8. Experimental tank at Pocahontas, Iowa.

During the summer of 1910, two such water tanks were constructed. The first, of 18,000 gallons capacity and supported by an 18x54-foot silo with a 5-inch wall, was located on the county farm of Pocahontas County (fig. 8). The other tank of 6,000 gallons capacity, supported on a 16x35-foot silo with a 4-inch wall, was located on the C. H. Hall farm near Glidden (fig. 9).

Some difficulties were encountered with the Pocahontas tank during the first winter which was rather severe. During the first cold weather a cake of ice approximately 22 inches thick formed on the surface of the water near the top of the tank. Later on a warm day, when the tank was about half full of water, the ice was released by thawing around the edges and fell, causing severe water hammer. No apparent damage to the tank resulted.

A report made in April, 1914, by W. G. Kaiser states that the tank was leaking badly. The inside of the silo was wet and the outside showed large streaks caused by the leaking water. The plaster coating was rough and badly cracked. The majority of the cracks ran horizontally and seemed to follow mortar joints around the wall. The largest one occurred at a line about 1 foot from the top. Since there were about 4 feet of water in the tank, it was not possible to observe the condition near the bottom on the inside. The presence of water and the poor condition of the clay block wall showed from the outside that a large part of the leakage came from the sides near the bottom. The blocks at the base of the tank and extending entirely around the tank in a belt two tiles wide, were spalling off and gave a dead sound when tapped.

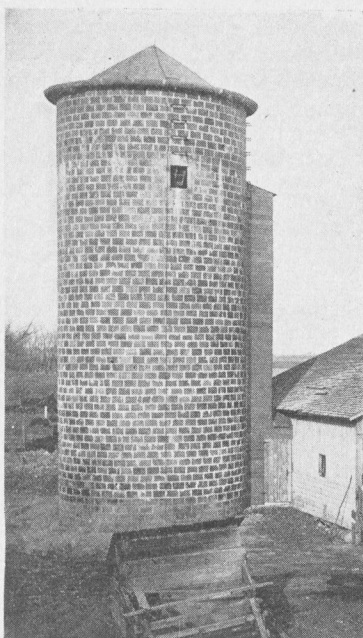
Fig. 9. Experimental tank at Glidden, Iowa.

The supply pipe in the Glidden tank also gave trouble during the winter of 1911-12 by freezing at the point where the pipe entered the tank bottom.

At the time of the 1914 report the Glidden tank was dry on the outside. A few damp spots showed at the bottom and near places where there had evidently been some attempt made at waterproofing. There were a few holes in the plaster where small pieces had popped out due to further hydration of the lime, and a line of exposed asphalt spots showed upon almost the entire circumference on the inside of the tank about 20 inches up from the bottom. The report indicates that the combined thickness of both the plaster and asphalt appeared to be less than  $\frac{1}{4}$  inch. This proved insufficient. The plaster and asphalt layers applied to the roof peeled off, apparently due to the weight of ice freezing to the plaster.

In the fall of the same year when Mr. Kaiser undertook to repair the tank at Glidden, it was leaking badly through cracks evidently produced by unequal expansion and contraction of the materials. Water that had seeped or condensed between the two walls froze, breaking a number of blocks in the outside wall. The tank was cleaned and defective blocks replaced.

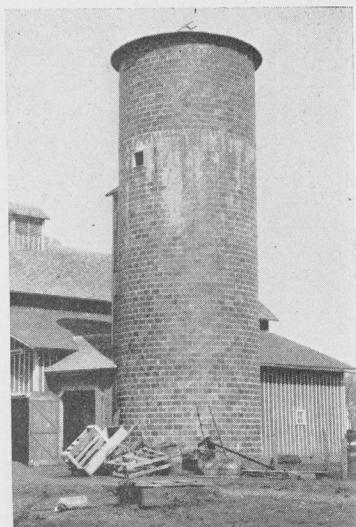
Fig. 10. Experimental tank at Whiting, Iowa.

A third tank was built in 1912 on the W. C. Whiting farm near Whiting (fig. 10). This was of approximately 13,500 gallons capacity and placed on a 16x40-foot silo. The construction of these tanks as finally developed is illustrated in fig. 11; it consisted first of an outer shell which was simply a continuation of the silo. Tiles were broken away on the inside of the silo so that the concrete floor of the tank could be supported by the silo wall but show no evidence on the outside. A conical shaped floor permitted the use of the same forms as were used in the construction of the roof. The tank proper was constructed independently of the outer wall. To permit the use of more reinforcement to resist the hydraulic pressure,

In 1914 the Whiting tank was leaking in places near the bottom. A layer of asphalt applied to the plaster in this tank was so thin in some places near the top as to expose the wall underneath and had peeled off entirely from the lower half of the tank. Rust on the asphalt indicated that the wall had not been thoroughly cleaned before the asphalt was applied. There was a crack about  $2\frac{1}{2}$  feet from the top of the tank which extended entirely around it. Both this tank and the

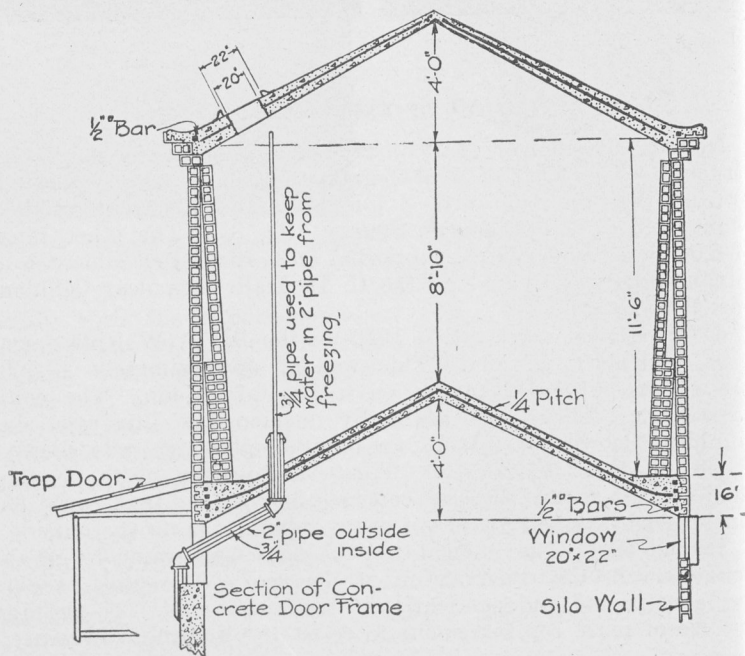
Fig. 11. Construction of original tanks.

the lower courses of tile were laid flat. The interior wall was covered with about  $\frac{1}{2}$  inch of cement plaster.

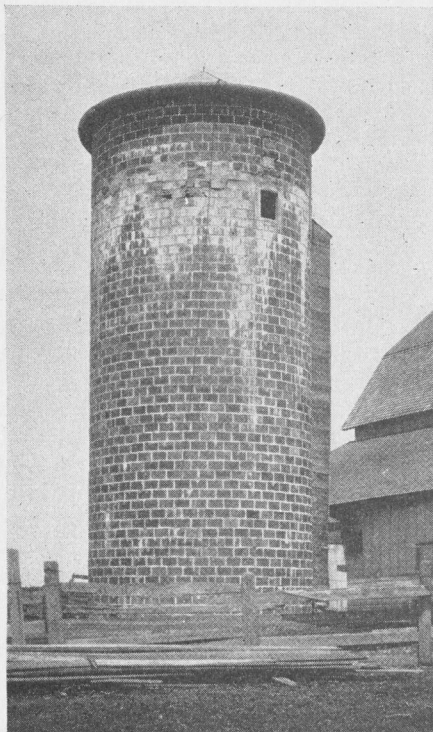
Fig. 12. Glidden tank showing deterioration.

In October, 1922, J. B. Davidson and W. A. Foster reported the tank in poor condition and disuse. The plaster had separated from the asphalt mastic and sluffed off from the roof. Mastic had flowed through cracks in the plaster side walls, but the plaster otherwise was still intact. The outside blocks were in bad condition.

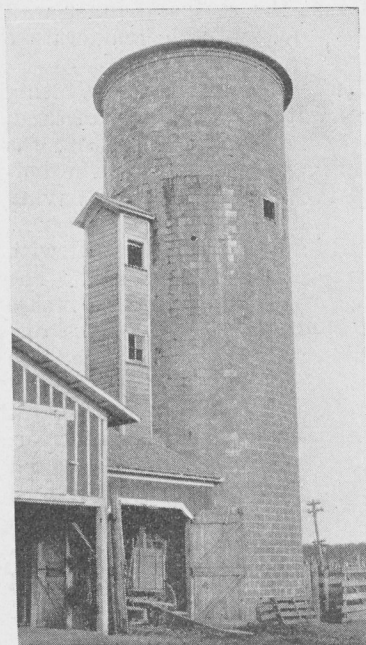
Fig. 13. Whiting tank in bad order.

A few of the blocks in the outside wall near the bottom of the tank showed evidence of deterioration. By June, 1926, however, the appearance changed considerably. The water leaking through the tank wall or that condensing between the walls had frozen and damaged the outer layers of tile near the bottom of the tank (figs. 13 and 14). In two or three instances the outer shell of the tile was entirely destroyed. Most of the tile in the courses mentioned showed some evidence of deterioration.

Because the tank showed considerable disintegration on the outside, a 12x8-foot wooded tank was placed on the inside, and the masonry tank has since served only as a housing. At the time this was done, a hole approximately 2 feet square was cut through the tank wall and outer wall just above the floor of the tank. After spending nearly a day in cutting this small hole it was decided that the tank was in much better condition than was apparent from the outside. With a little attention to waterproofing and the improvement of some constructional details, it would have lasted indefinitely. The cork pipe covering has given very satisfactory service.

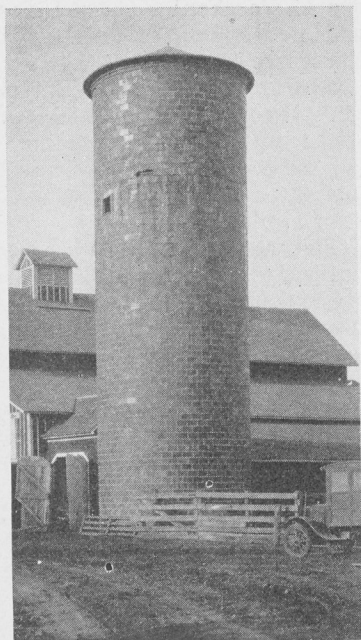
Fig. 14. Another view of the Whiting tank.

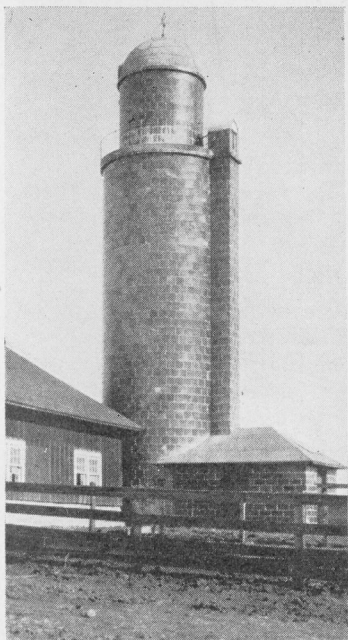
Fig. 15. Tank at Lisbon, Iowa.

In addition to making tests on the above tanks, observations have been made on others. In figs. 15 and 16 are shown two tanks which have fallen into disuse because of inadequate insulation. No insulation was provided either in the tank walls or in the supply pipes. As a consequence the water in the pipes

froze at the outset of cold weather. Since no water could flow through the pipes, all the water in the tanks froze, eventually disintegrating the tile as can readily be seen in the photographs. Thus good specimens of masonry construction become ineffective because of the lack of attention to a few details. Figure 15 shows a modification of the original plan in that the tank proper

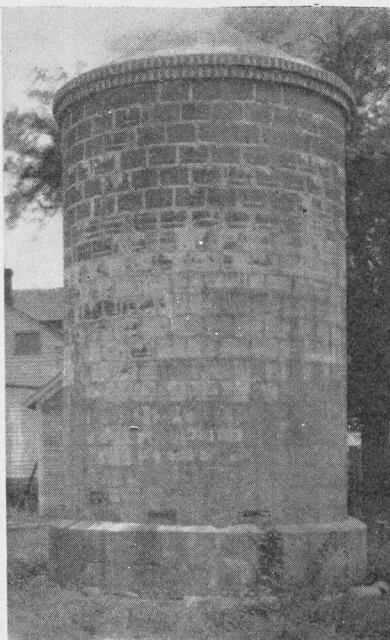
Fig. 16. Tank near Muscatine, Iowa.

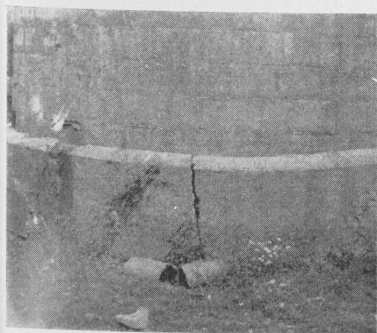
Fig. 17 Tank with cracked foundation.

Careful attention should be given to foundations. Figure 17 shows a tank built

on the ground. The cracked foundation doubtless resulted from the fact that it did not extend into the ground below the frost line.

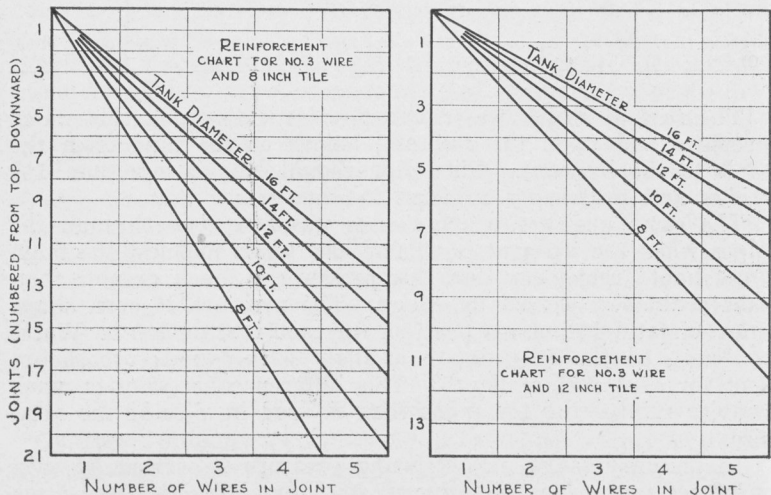
Fig. 18. Reinforcing schedule—tile walls.

From fig. 18 one can determine the number of No. 3 wires necessary for clay block tanks using either 8-inch or 12-inch blocks. It will be noted that in the larger tank sizes so many wires are required for the 12-inch tile that their use becomes questionable. On the other hand, brick (fig. 19) with more joints per foot requires less reinforcing per joint.

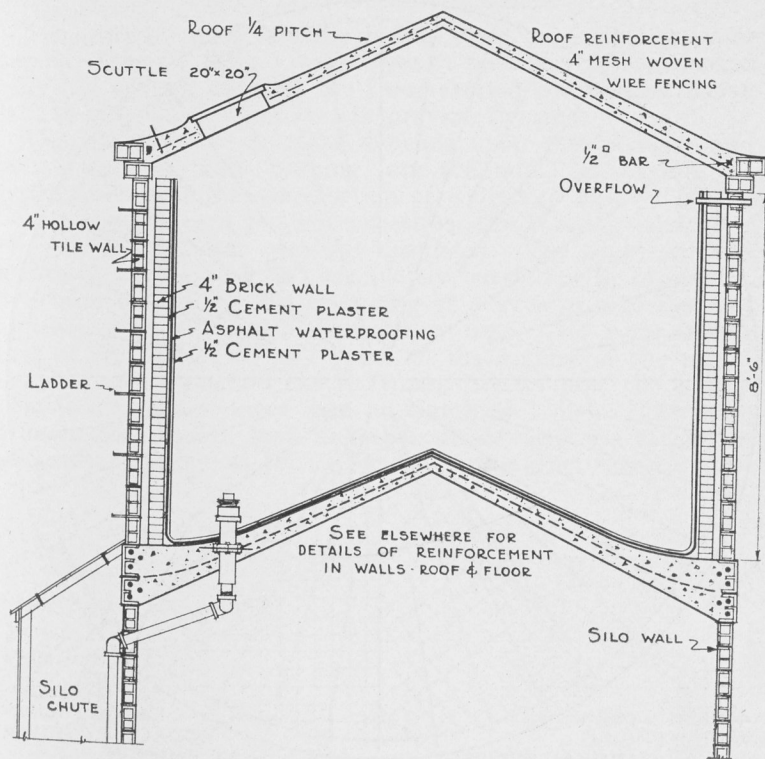
Fig. 19. Brick walled tank construction.

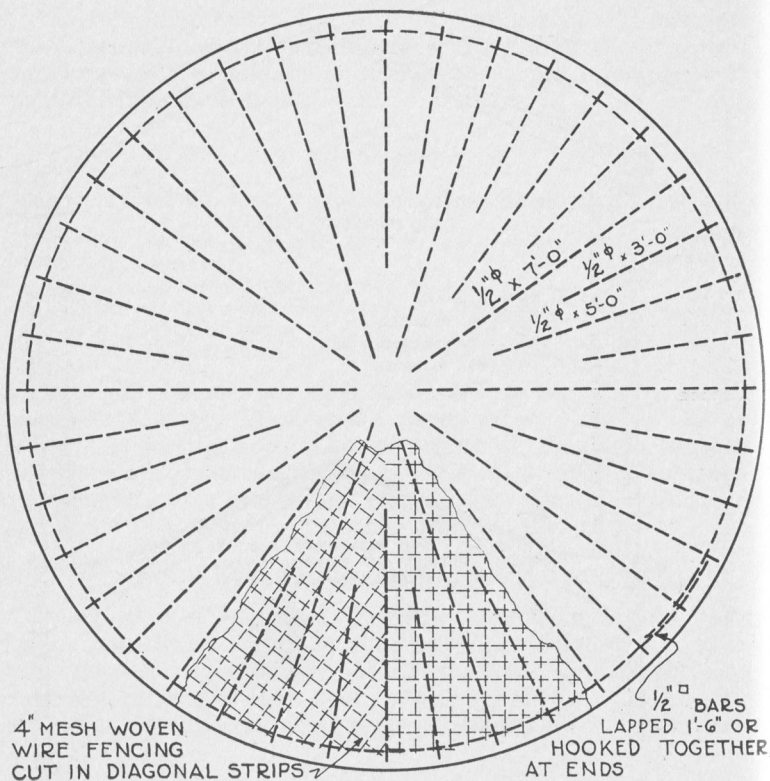
Fig. 20. Reinforcing of conical floor.

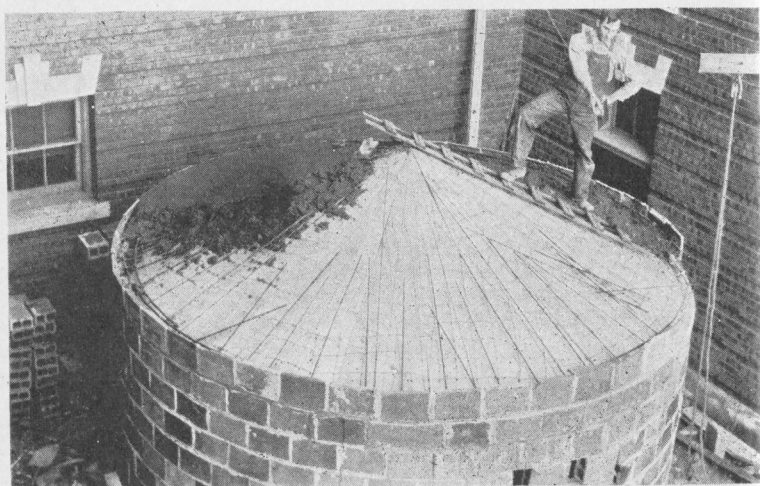
Fig. 21. Construction of conical roof.

A conical roof was used with the original Iowa silo. Since forms were already on the job for constructing this type of roof, the investigators felt the desirability of using the same construction for the tank floor. The conical roof and floor construction, although requiring some additional labor and material

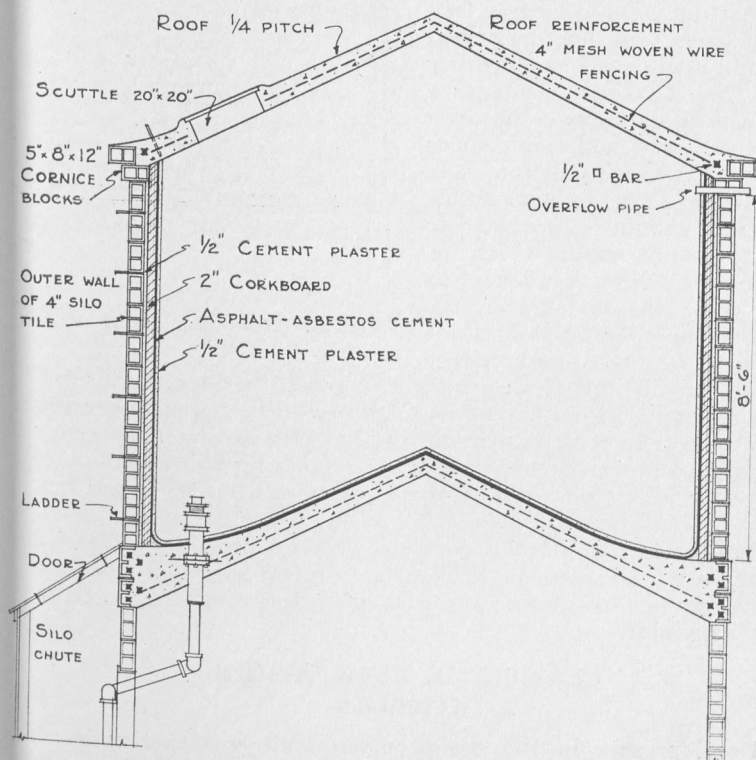
Fig. 22. Tank lined with cork insulation.

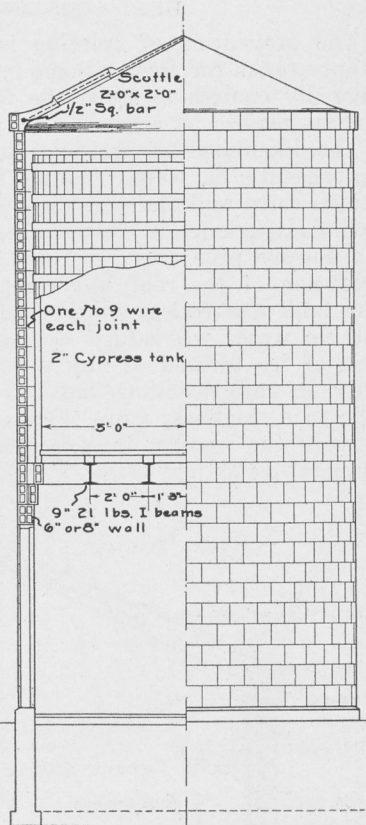
Fig. 23. Wood tank in tile silo shell.

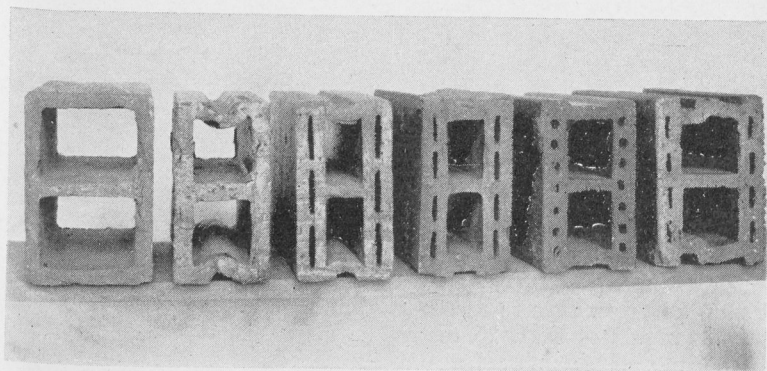
Fig. 24. Development in silo tile design.

built. The plain single-walled blocks at the left in fig. 24 made tight walled construction difficult. The newer designs shown to the right with thicker walls and openings which provide a key between tile and mortar provide a wall which can be more easily made waterproof.

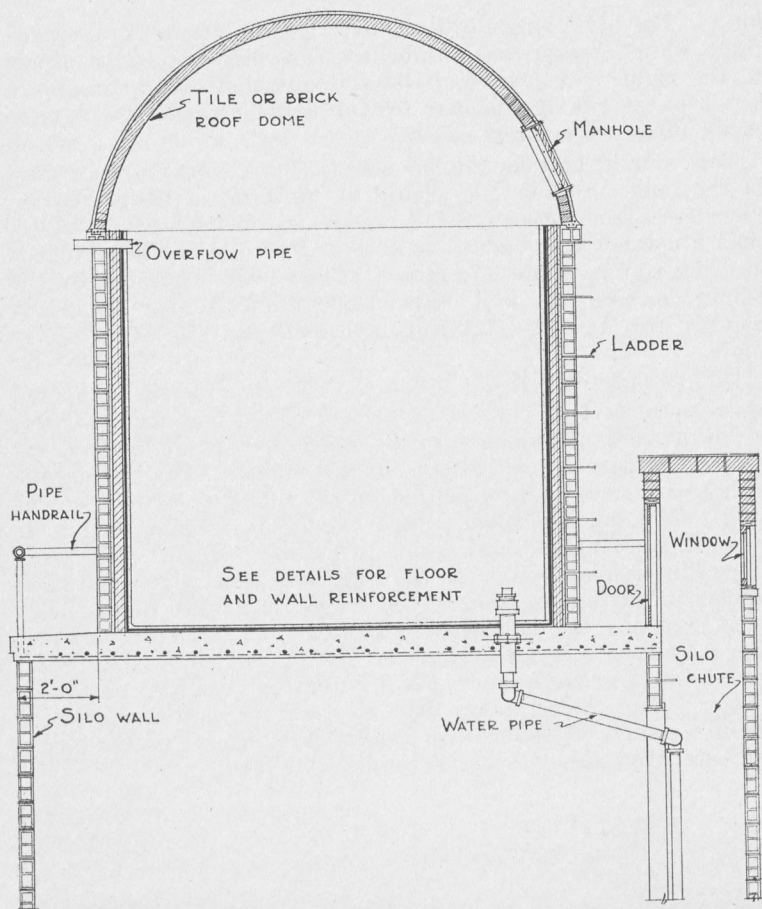
Fig. 25. Design for clay block tank smaller than silo.

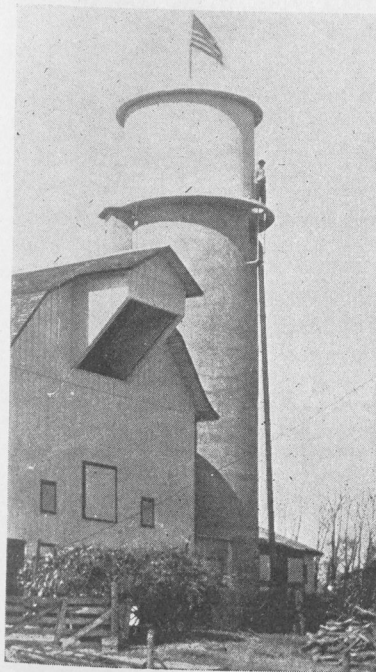
Fig. 26. Monolithic concrete tank.

Concrete has given satisfaction in the construction of many masonry supply tanks (fig. 26). The discussion here relates to the selection of materials as well as the design and construction. Tanks may be either of monolithic (cast in place) construction or be made by the assembling of small pre-cast units.

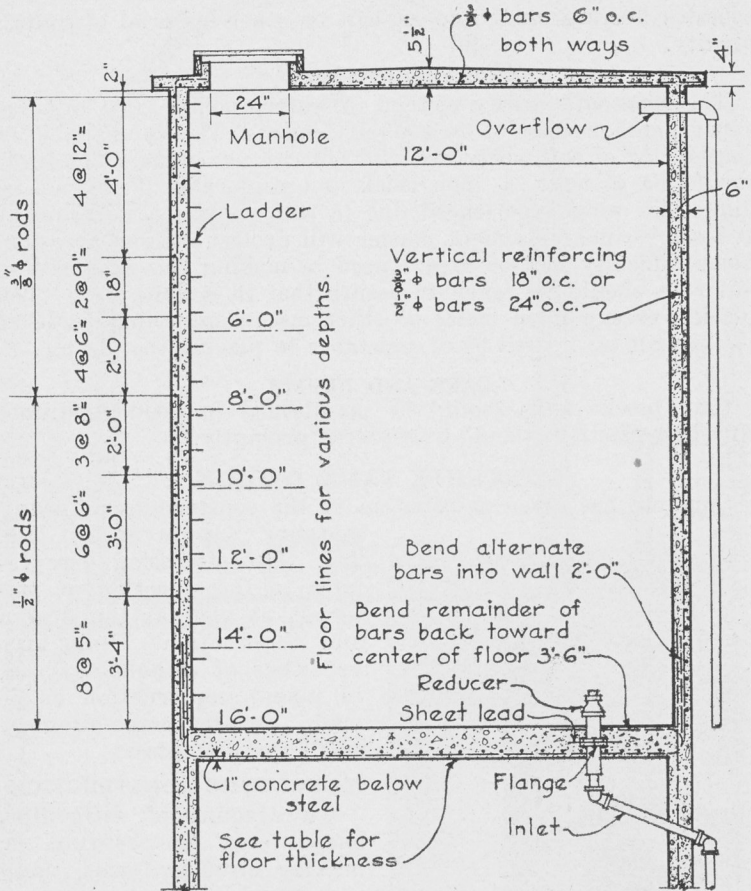
Fig. 27. Reinforcing schedule for monolithic concrete tank.

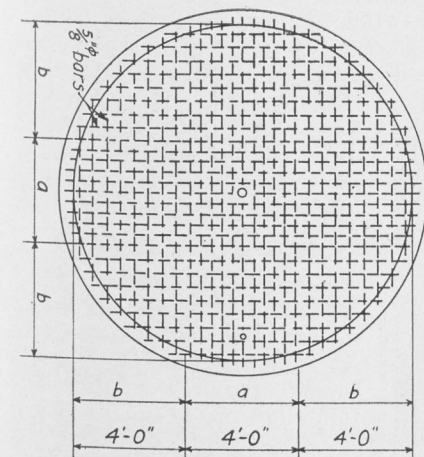
Fig. 28. Reinforcing schedule for concrete floor slab.

for centering, is well adapted by form to carry heavy loads, and the amount of reinforcement required is small compared with that needed for flat construction. With the exception of a limited amount of steel to resist shear in the roof proper, the major portion of the reinforcement may be placed in the base of the cone in the form of continuous hoops or circles. A tank floor obviously requires more strength than a roof, although many conical concrete roofs have been built sufficiently strong for a tank floor if additional reinforcements were added at the base of the cone. This conical shape also has made possible the construction of tanks on top of silos already built. The design of this roof is shown in fig. 20, and the method of construction is illustrated in fig. 21. Recently a hemispherical roof made with brick or special roofing tile has been popular (figs. 4 and 25). The design of a flat slab for this purpose may be found in fig. 28.

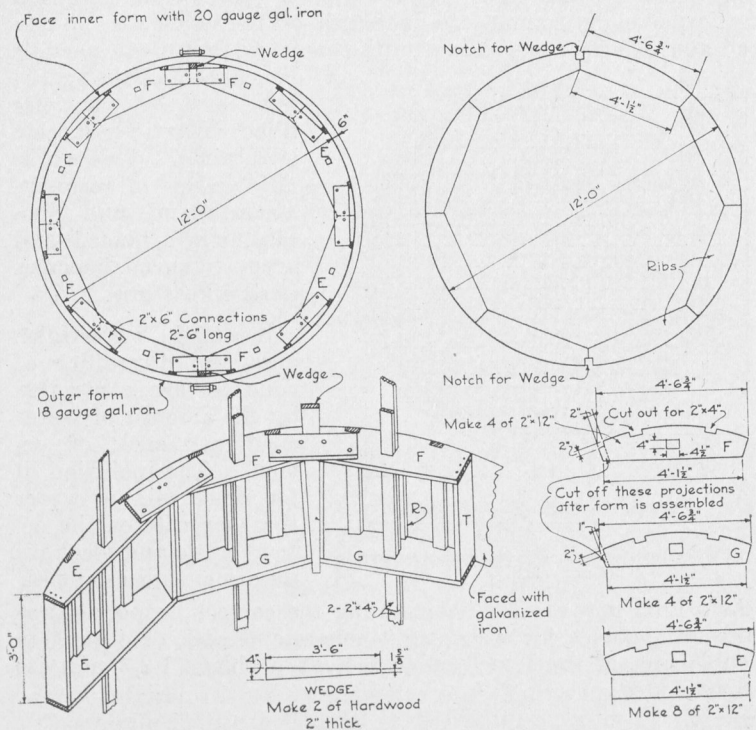
Fig. 29. Forms for casting circular tank.

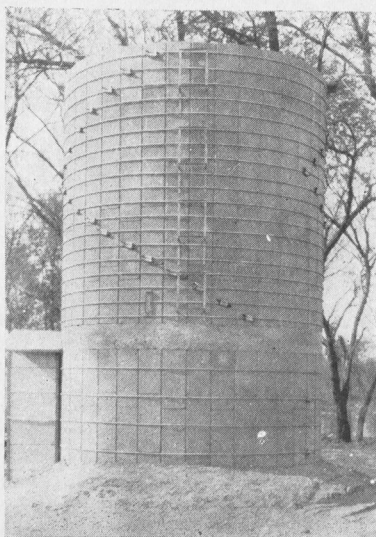
Fig. 30. Concrete stave tank.

The essential difference between the monolithic and the stave tank (fig. 30) lies in the method of placing the reinforcing. Pre-cast staves are held in place by metal hoops. Rules applying to reinforcing will also govern the size and spacing of hoops. Since the staves are usually 2 inches in thickness, much thinner than the corresponding section of the monolithic tank, it is even more essential that great care be taken in making the staves. Good

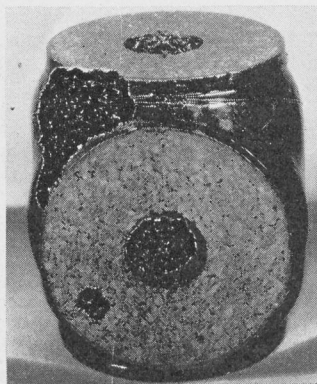
Fig. 32. Cork pipe covering.

molded joints has given satisfaction (fig. 32). The material will not sag leaving open joints. Special shapes protect the pipe fittings equally well with other portions of the pipe. Cork is also highly resistant to the penetration of moisture.

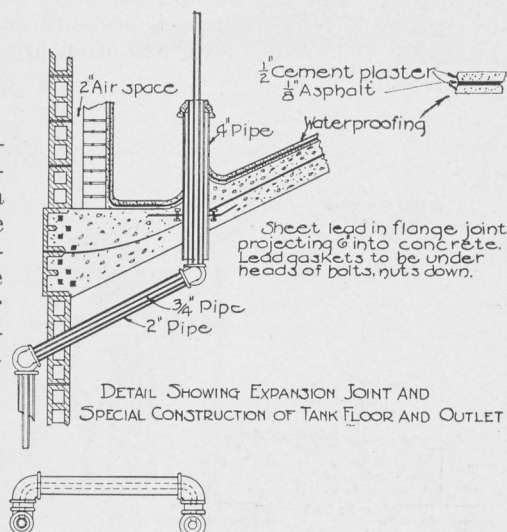
DETAIL SHOWING EXPANSION JOINT AND SPECIAL CONSTRUCTION OF TANK FLOOR AND OUTLET

Fig. 34. Pipe expansion joint.

The supply pipe should not come in direct contact with the concrete floor. Much difficulty from freezing and leakage can be avoided by using the method shown in fig. 34. It is usually

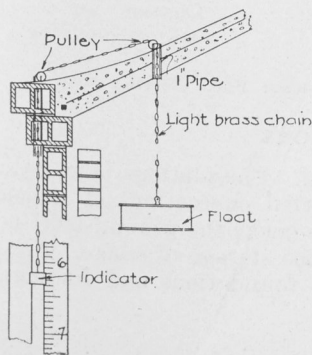
Fig. 35. Water level indicator.

Every tank should be equipped with a water level indicator and overflow pipe. The customary method used consists of a float on the surface of the water connected by means of a chain to a weighted indicator on the outside wall of the tank (fig. 35). The indicator following a guide shows on a large scale the feet of water. The scale is, of course, reversed as the indicator is at the bottom when the tank

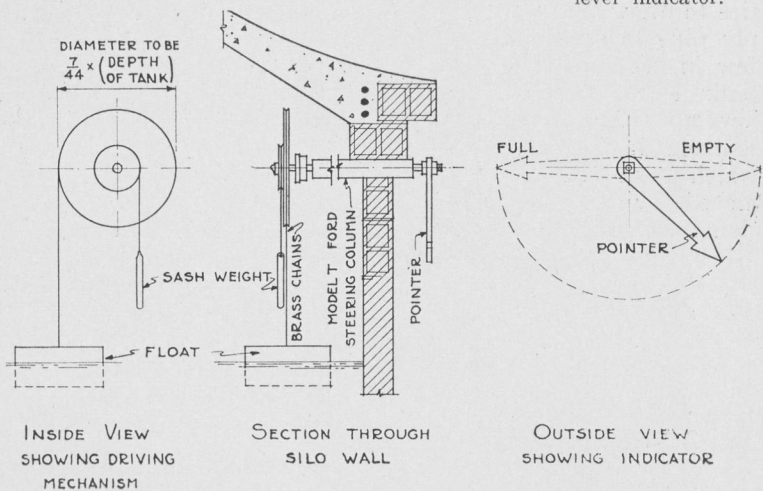
Fig. 37. Water level indicator using Ford steering post.

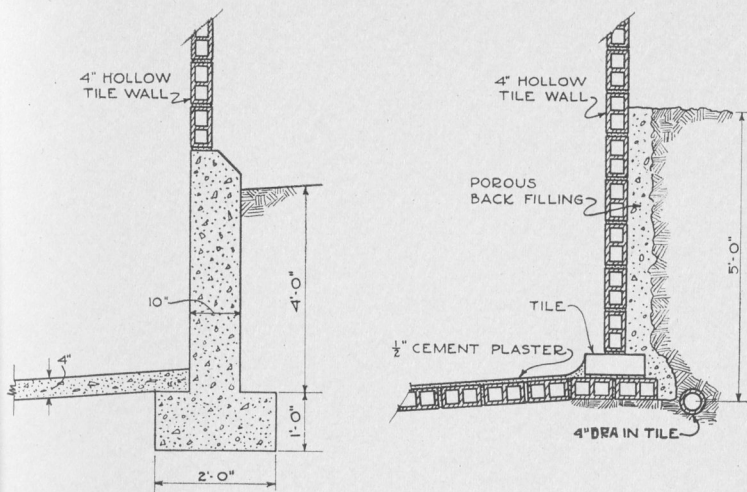
Fig. 38. Design for foundations and footings.

The tank must be well supported. Foundations must extend below the frost line and be supported on footings of sufficient size to prevent settling. The space below the ground level need not be lost but can be utilized for the storage of silage. Fig. 38 shows recommended sizes for both foundations and footings.
